EARTHQUAKE

Long Beach 1933 — Coalinga 1983 But With a Difference

by James E. Amrhein¹, S.E. & Juan A. Giron²

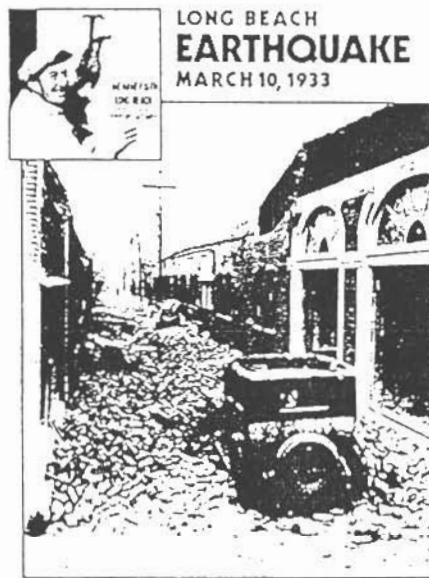
Fig. 2. Damage to unreinforced masonry buildings in the March 10, 1933, earthquake of Long Beach.

The size of the earthquake, 6.5 on the Richter scale, was approximately the same that hit the city of Long Beach in 1933. The devastation, the collapse of buildings, the falling out of unreinforced masonry walls was seen in Long Beach (Fig. 2) as well as in Coalinga.

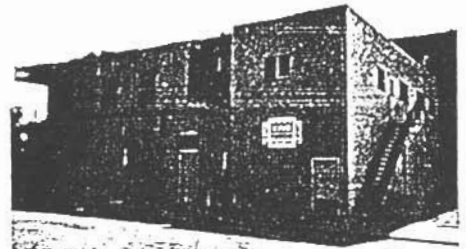
Building Official John Wyse of the County of Fresno Building and Safety Division, took us in there and explained, "I want to show you the difference between old masonry and new masonry." Walking through the store, we saw damage throughout and damage on the outside of the building. Then, going into the rear of the store, we entered a new two-story addition of reinforced concrete block masonry, and the building official told us, "This is where the people came to be safe." This was a modern two-story reinforced concrete addition to the old, unreinforced masonry building, and it performed very well (Fig. 7). The building official explained that there were no cracks in the new masonry addition and it came through just like we wished all buildings would.

Fig. 7. Building at 5th St. and Durian Ave. (left), unreinforced masonry dress shop; on the right, new 2-story addition.

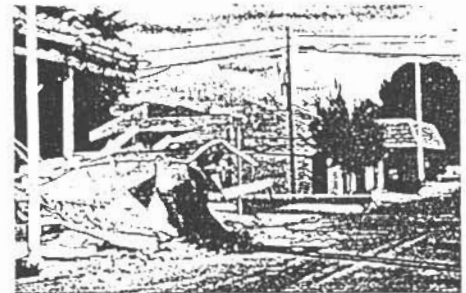
Fig. 8. On 5th St. in Coalinga Plaza looking north, unreinforced masonry building that collapsed; reinforced concrete masonry real estate office building (center) came through without damage.

At the corner of Cedar Street and 5th Avenue there was an old, unreinforced masonry building that was virtually destroyed. Across the street on the northwest corner was a new one-story Vernard & Whitmore real estate building of reinforced slumped block that survived the earthquake with no damage (Fig. 8).

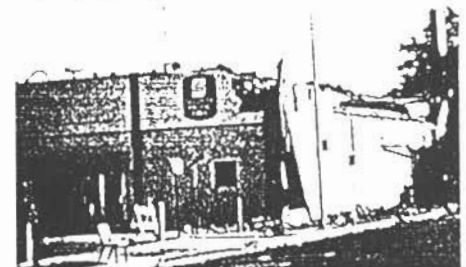
Fig. 9. Old, unreinforced masonry building — Security Pacific Bank — note parapets fallen off.

(Fig. 9) The Security Pacific Bank on the corner of Durian and Coalinga

Plaza suffered significant damage to the parapets and unreinforced masonry walls. Immediately next to this building was McMahan's Furniture store (Fig. 10). This reinforced concrete masonry building performed extremely well with no broken windows and only slight cracks along the base, indicating high shears developing within the system but no damage to the building itself. The masonry walls performed well, including the parapets.

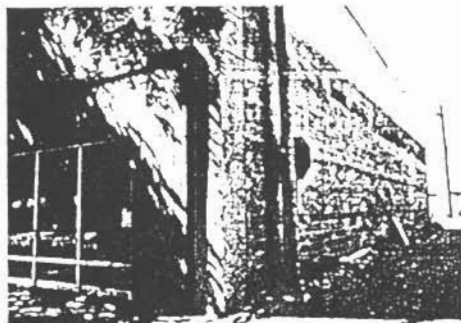
Fig. 10. Next to the Security Pacific Bank is McMahan's Furniture store of modern reinforced concrete masonry; no damage.

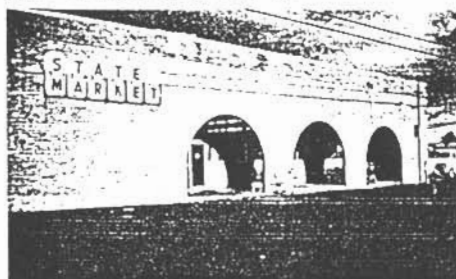
Fig. 11. State Market — reinforced masonry; no damage.

There were a number of modern masonry buildings that performed extremely well, such as State's Market (Fig. 11). John Kariolis, structural engineer of Pasadena, reported that the equipment on the roof was displaced and moved around, indicating that the building was subjected to very high seismic velocity, but the masonry walls came through unscathed.

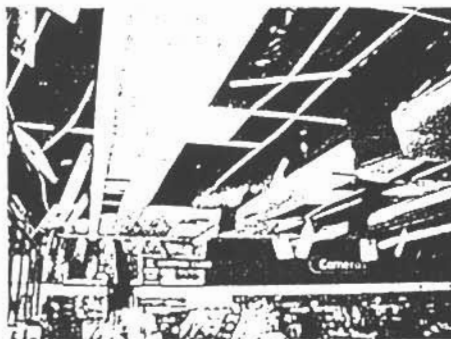
The L&M Equipment building, still in operation, performed well, as did the hardware store on Forest and 5th. Whereas the Thrifty Drug Store (Fig. 12) suffered serious damage at the suspended tee bar ceiling, however, the main concrete masonry building performed very well.

Fig. 12. Thrifty Drug Store — T-bar ceiling with panels displaced and fallen out.

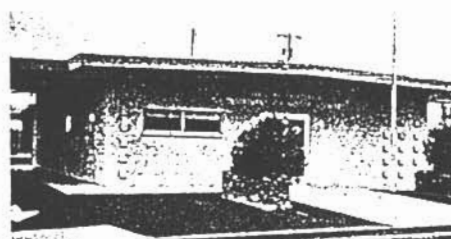
Fig. 13. Department of Motor Vehicles — No damage to the concrete masonry building.

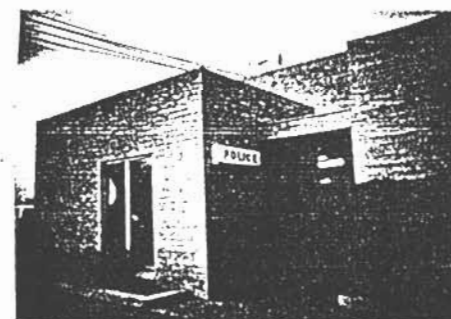
One of the very fine buildings was the police station. This was in the heart of downtown, and the inquiry to the desk sergeant indicated that they had suffered serious damage of bookcases thrown over, desks moved around, and disruption of equipment; however, there was no damage to the building itself. Personal inspection confirmed this statement (Fig. 14).

Fig. 14. Police headquarters — The reinforced concrete masonry survived without damage.

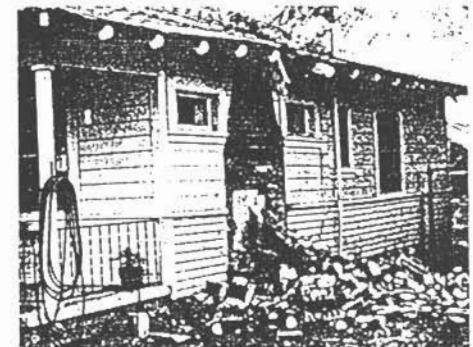
One of the distressing features of this earthquake was the performance of the unreinforced, unanchored chimneys. These chimneys broke off at the roof line, they failed through the fireboxes, or they peeled away from the buildings themselves (Fig. 16). When the chimney was well anchored and reinforced, it did perform.

Fig. 16. Unreinforced brick masonry peeled away from the house; no ties.

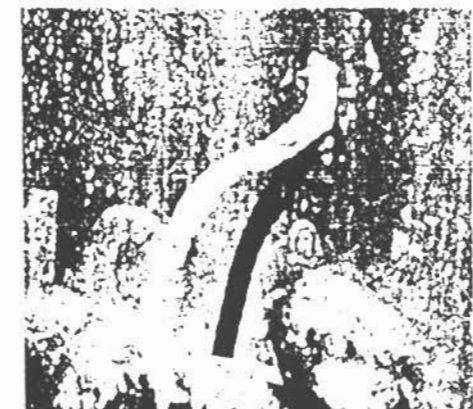
The anchored masonry veneer did not perform too well because of the way it was secured. The corrugated tie (Fig. 17) did not anchor the masonry veneer, which pulled away from the wall. Anchored veneer was damaged throughout the area, as shown in Blair's Iron Works on Forest Avenue. At the Blair

Fig. 17. Corrugated metal ties did not hold the stone veneer in place.

We have also seen that veneer anchorages must be improved. Corrugated metal ties do not hold the masonry. Adequate anchorage to the supporting wall is required. Adhered veneer performed well as it is light and, with adequate adhesion, did not cause any problems.

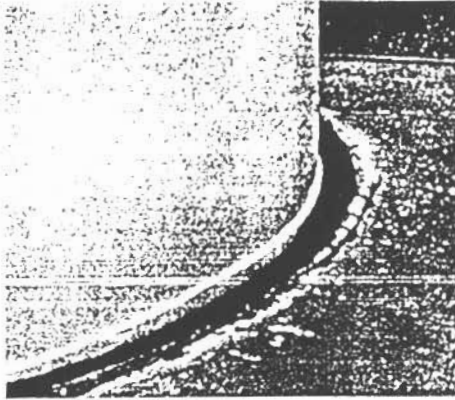
Fig. 18. Fuel tanks moved approximately eight inches.

There were two tank frames with three tanks in each. Luckily, they were empty and therefore did not suffer a compression elephant foot failure around the base or collapse due to weight of contents. However, all tanks at each location displaced approximately 8" (Fig. 18) and broke some of the piping attached to them.

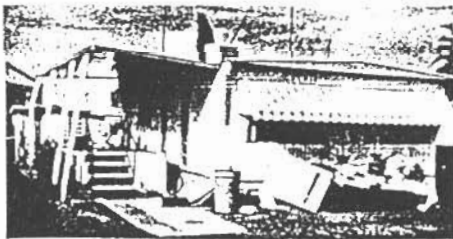
The Fairview Mobile Home Park on Thompson Street suffered much damage. The trailers were up on small sheet metal pedestals and these pedestals collapsed or turned over and the trailers dropped approximately 18 inches (Fig. 19).

Fig. 19. Approximately 80% of the trailers were displaced off their light steel piers and collapsed.

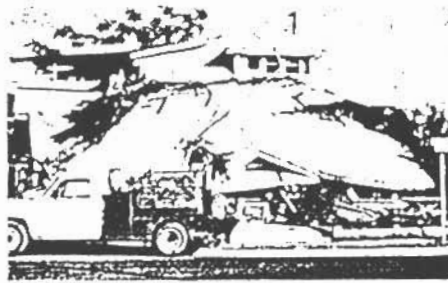
There were many warning signs posted on residential homes. These homes were built in the 1920s and 1930s and were supported off the foundation on 4" x 4" cripples about 12" high. The ground motion caused the buildings to rock back and forth and collapse just like dominoes. The cripples gave way and the buildings all were displaced

Fig. 20. Home collapsed in the earthquake.

(Fig. 20). In addition, many water pipes and gas lines to the homes were broken or disrupted. These homes suffered chimney damage as well as displacement and falling away from the porches.

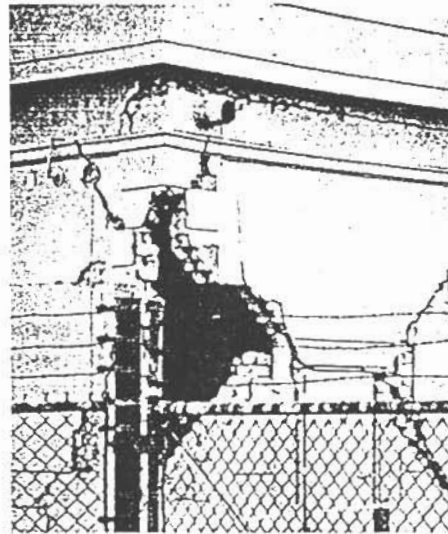
Fig. 21. P.G.&E. Substation & Warehouse — unreinforced concrete masonry power station showing diagonal cracks of in-plane failure.

On the outskirts of town at Merced and Jayne Avenue, the P.G.&E. Substation & Warehouse was located. This old, small unreinforced masonry building was significantly damaged (Fig. 21). In-plane forces were acting, causing high diagonal tension stresses on the unreinforced wall. The significant ground acceleration imposed high loads upon this building.

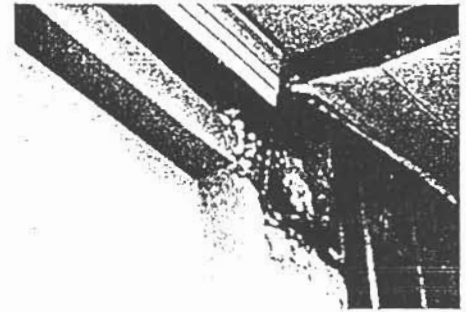
Fig. 22. J.C. Penney building — anchor bolts pulled free from cast-in-place concrete pilaster column.

Ties around anchor bolts are important, as shown in the J.C. Penney building (Fig. 22), where large anchor bolts were pulled out of the cast concrete pilasters. Current requirements call for #3 or #4 ties to be imbedded and to tie the anchor bolts to the main reinforcing.
