EARTHQUAKE

Long Beach 1933 — Coalinga 1983 But With a Difference

by James E. Amrhein¹, S.E. & Juan A. Giron²

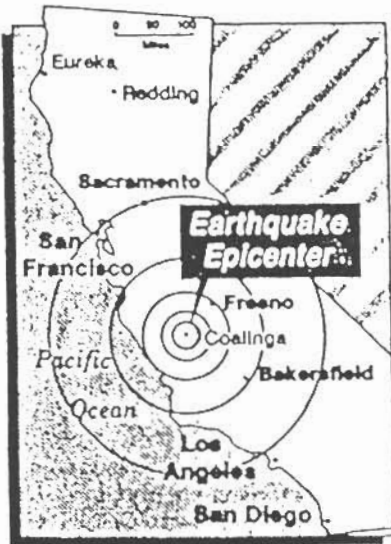
Fig. 1. The epicenter of the earthquake was approximately five miles northeast of the city of Coalinga.

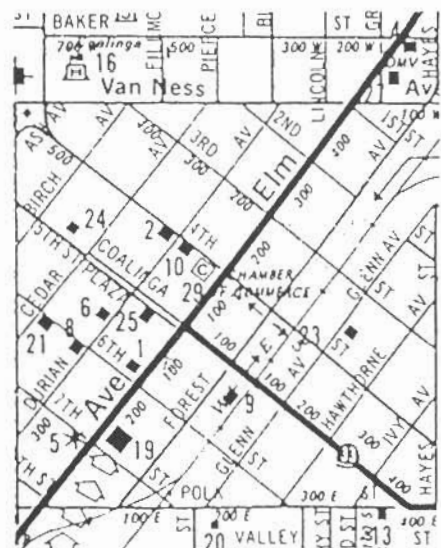
The general downtown area suffered major devastation from 4th Street to 7th Street and from Forest Avenue to Durian Avenue. This was the area that was well secured by police and highway patrol (Fig. 3).

Fig. 3. Map of downtown central area of Coalinga.

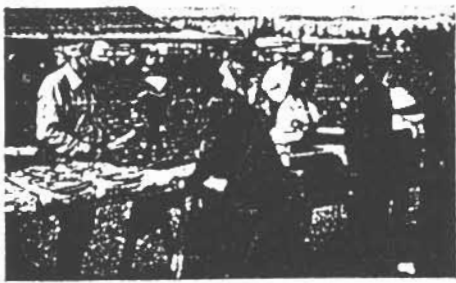
Fig. 4. National Guard distributing food; note dining tent in the rear.

The California National Guard came in immediately (Fig. 4) and set up emergency food distribution field kitchens and dining tents. The next day, Tuesday, the National Guard and the Salvation Army were feeding hundreds, and by Thursday they were feeding thousands.

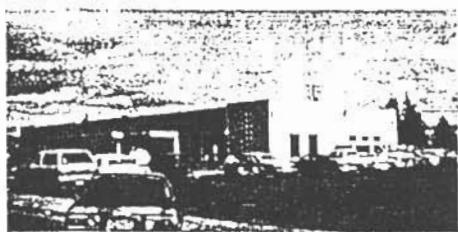
As a result of this activity, certain buildings were designated safe command posts and business centers. Included in these command posts were the Highway Patrol Office, the Elk's Lodge (Fig. 5), and the West Hills College in

Fig. 5. Elk's Lodge No. 1613 served as central command post for the building inspection services.
